**POLARIS****TECHNICAL SERVICE BULLETIN**

Bulletin Number: A-17-01-B

SUBJECT:**2016 Sportsman 850/1000 High Lifter Edition Thermal Protection Update****PURPOSE:**

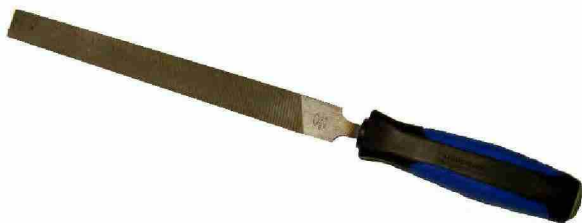
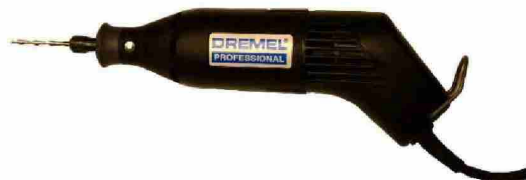
- Multi-function Pliers (Tuflok removal tool)
- T-27 Torx Driver
- T-40 Torx Driver
- 10 mm Combination Wrench
- 6 mm, 17 mm, 10 mm, and 11 mm Sockets
- Locking Pliers
- Suitable Flat Bladed Tool
- Hand Held Drill
- 3/16" Drill bit
- Rivet Gun
- Scissors or utility knife
- Paper
- Half Round File (shown below)
- Paint Pen (White or Yellow)
- Brake Clean or Comparable Solvent
- Water
- Sponge or Cloth
- Lint Free Cloth
- Driver for sockets (Breaker Bar, Ratchet, or equivalent)
- Dish Soap
- DREMEL® with a two flute bit intended for plastics, a reciprocating saw or similar device (shown below)

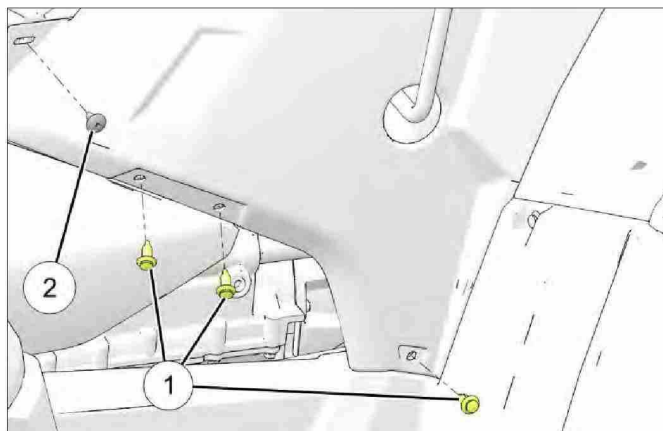
1. Remove the seat.
2. Using multi-function pliers, remove the three Tuflok fasteners ①. Using a T-27 Torx driver, remove the screw ② that retains the lower half of the right-hand upper side panel.

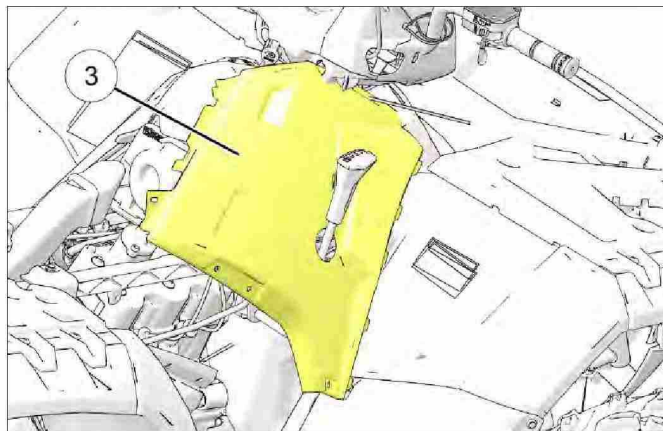
3. Remove the upper side panel ③.

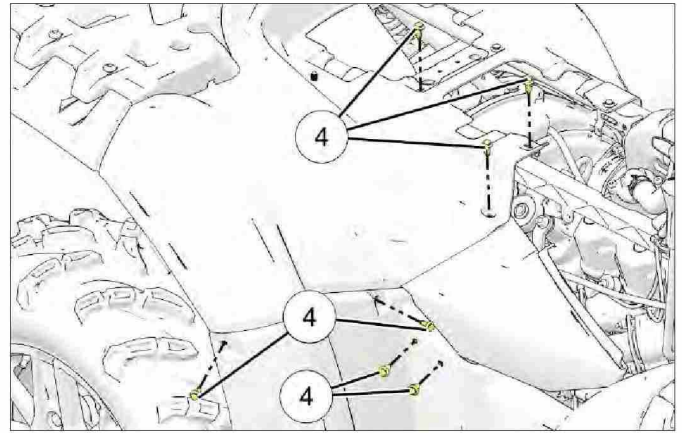
4. Using a multi-function pliers, remove the seven Tuflok fasteners ④ retaining the exhaust manifold side panel, footwell, and rear cab.

One tuflok will not be re-used, and can be discarded.

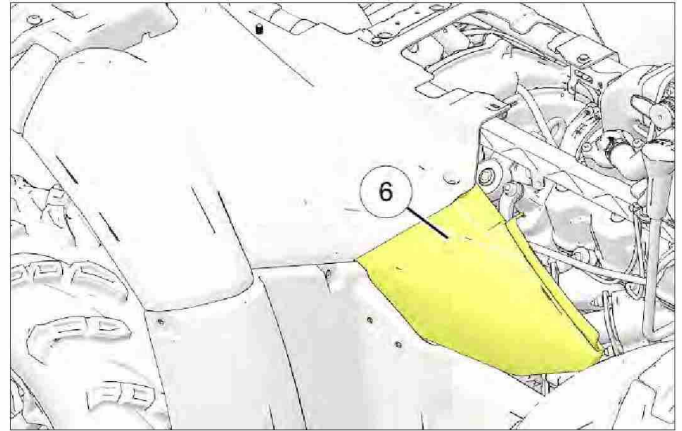
5. Remove the exhaust manifold side panel ⑥ and discard.

Discard the original exhaust manifold side panel at this time.

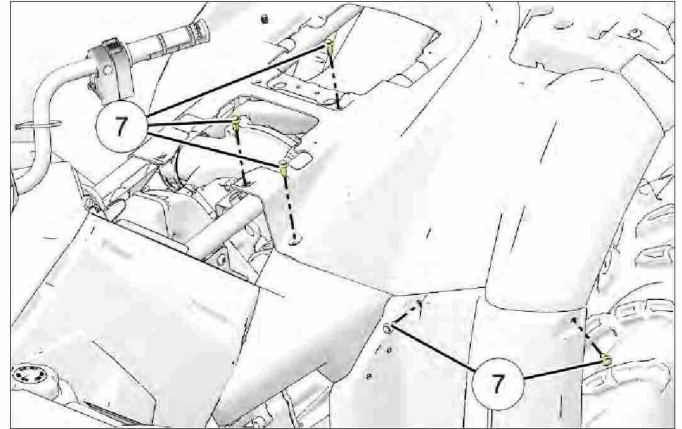
6. Using multi-function pliers, remove the five Tuflok fasteners ⑦ retaining the rear cab.

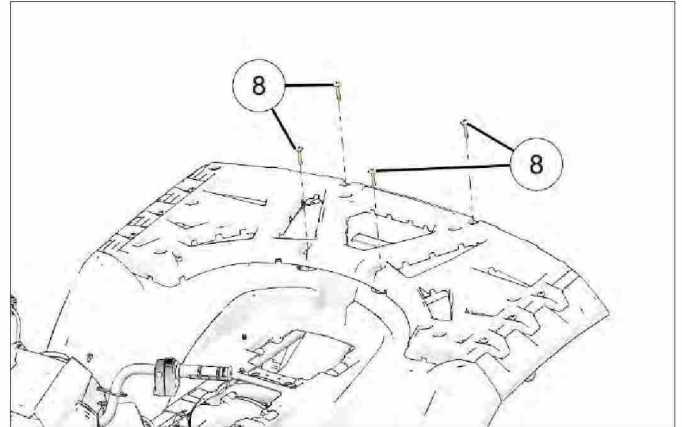
7. Using a T-27 Torx driver, remove the center four screws ⑧ retaining the rear rack/cab assembly.

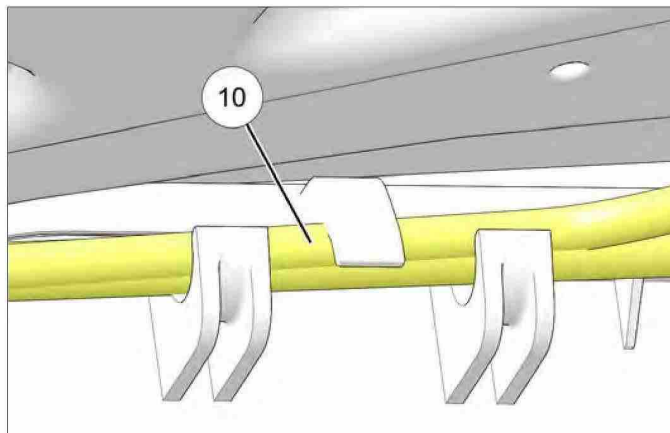
9. Remove the taillight harness (10) from storage compartment clasps and hinge clip.

Inspect the taillight wiring harness. If the convoluted tubing or reflective tape is damaged, take photos of the affected components and submit an ASK Polaris case for review by Tech Service.

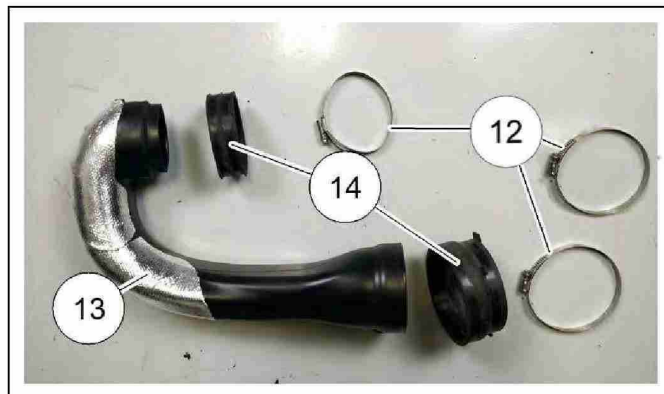
12. Remove the right rear outlet duct. Discard the clutch duct boots (14), right rear outlet duct with the fiber foil (13), and three worm clamps (12).

One clamp will be re-used later in this procedure. Discard three and retain one worm clamp.

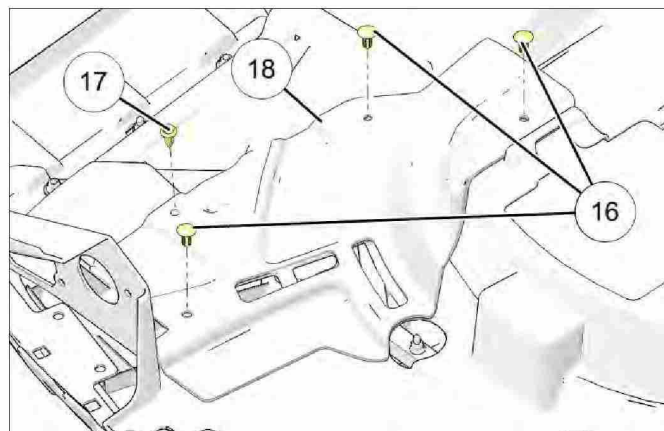
13. Using a multi-function pliers, remove the nylon plastic dart clips (16) and Tuflock fastener (17) that retain the rear cab heat shield (18).

Discard the original rear cab heat shield and fasteners (three dart clips and one Tuflok) at this time.

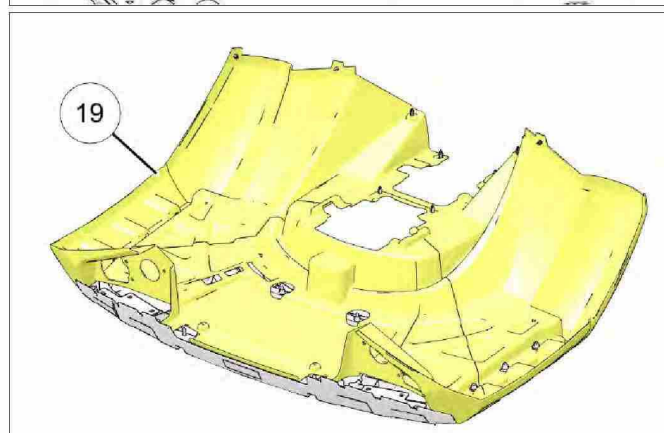
14. Inspect the rear cab (19).

A secondary dealer representative must verify the rear cab is not deformed.

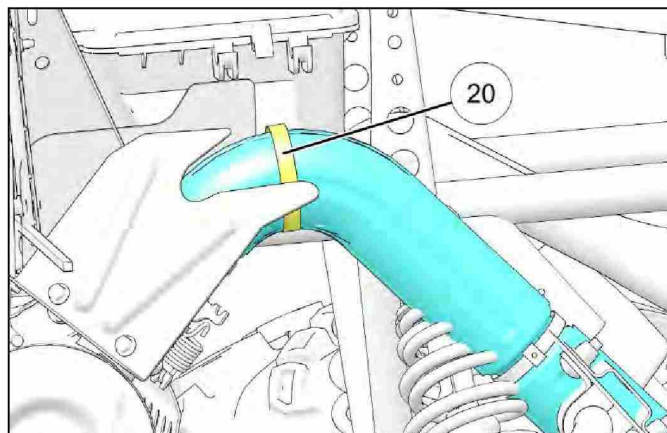
16. Verify the exhaust worm clamp (20) is in good condition and fastened as shown.

If the clamp is missing or damaged, file an ASK Polaris case requesting replacement.

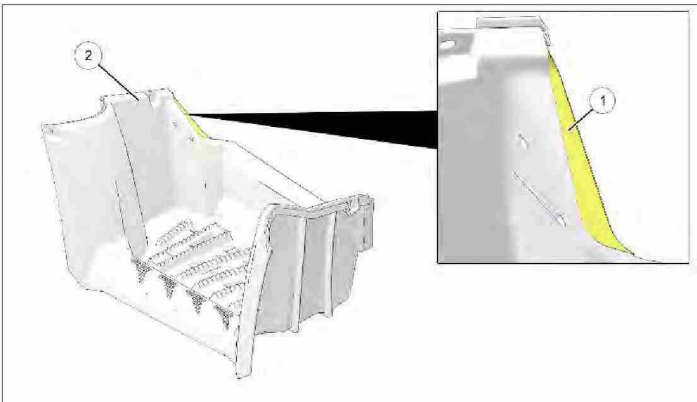
2. Place the provided template ① on the right-hand footwell ② as shown, then mark the perimeter of the template to outline the area to be trimmed with a paint pen.

| Use the inside and back edges of the footwell to locate the template. |

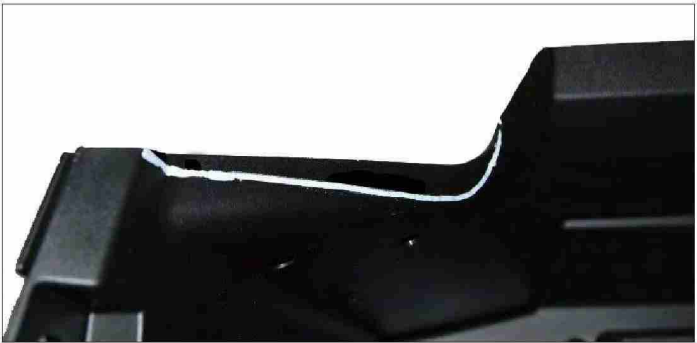
4. Trim the footwell using a DREMEL® with a two flute bit intended for plastics, a reciprocating saw or similar device leaving some material between the trim line and the paint pen line.

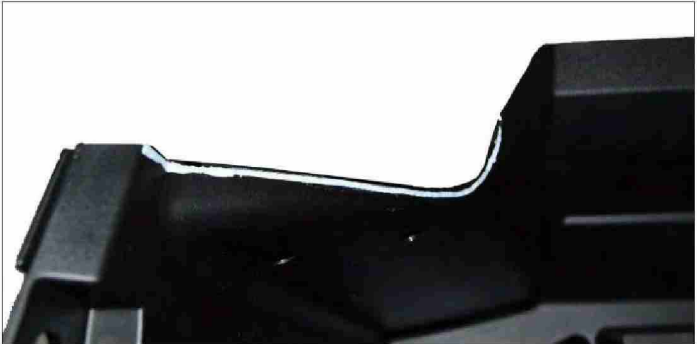
| Do not trim up to the line with one cut. Cut the majority of the material then file up to the line, but leave the line. |

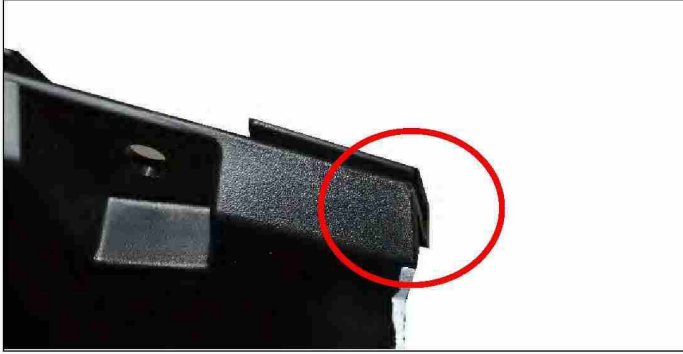
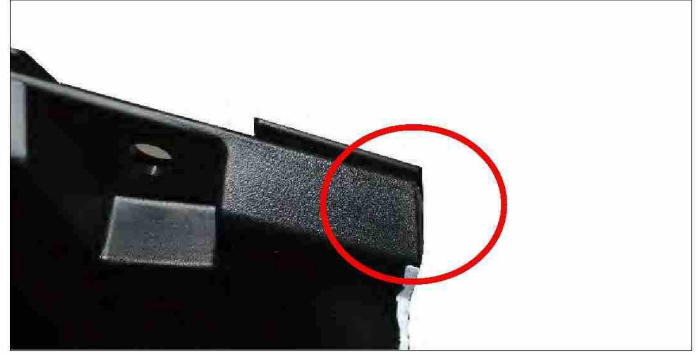
5. Using a DREMEL® with a two flute bit intended for plastics, a reciprocating saw or similar device, trim the footwell corner in line with the template (area circled in red shown in the **Before** and **After** images below).

Before

After

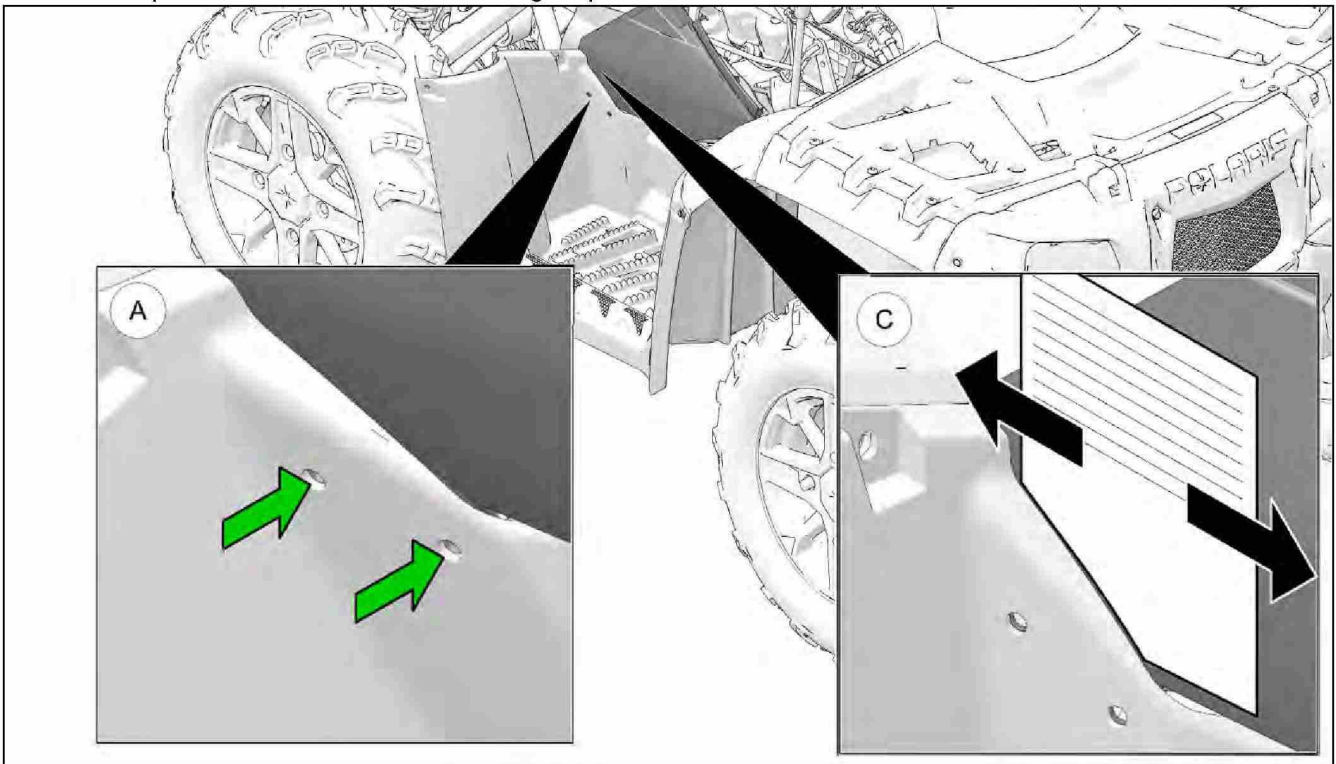
6. Test fit the new panel to verify the area trimmed area of the footwell does not contact the exhaust manifold side panel.
- Align the exhaust manifold side panel mounting holes.
 - Apply pressure to the footwell at the mounting holes.
 - Slide a piece of paper along the gap between the two panels.
 - If the paper slow or stops or the metal shield makes contact with the footwell, use a half-round file to trim the footwell to create a clearance gap between the components.
 - If the paper freely travels the length of the gap, and the metal shield does not contact the footwell, proceed to the audit and following steps.

A secondary dealer representative must verify that the trimmed edge of the footwell does not contact the new exhaust manifold side panel.

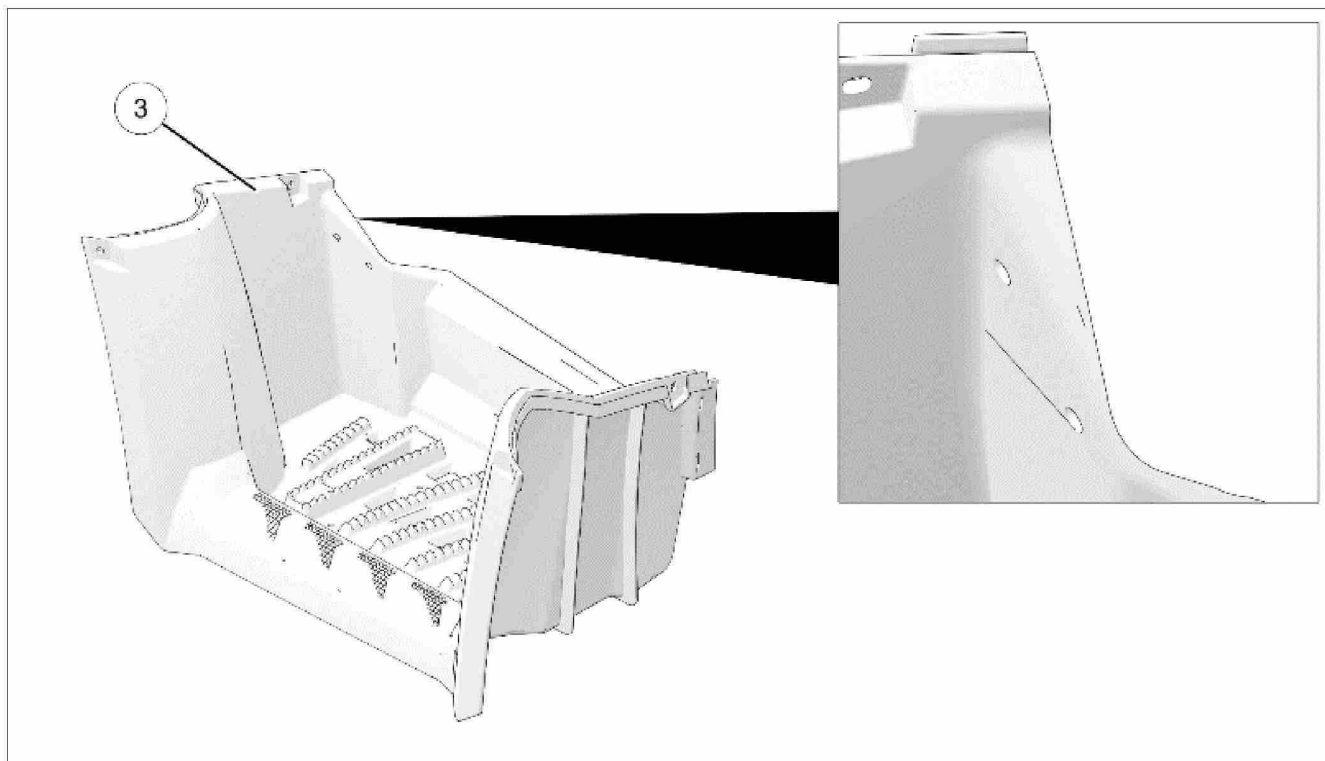
7. Using a half-round file, file and deburr the trimmed footwell ③. Ensure the footwell is clean, free of burrs, and maintains rider appeal. Verify trimmed area appears as shown in the illustration below.

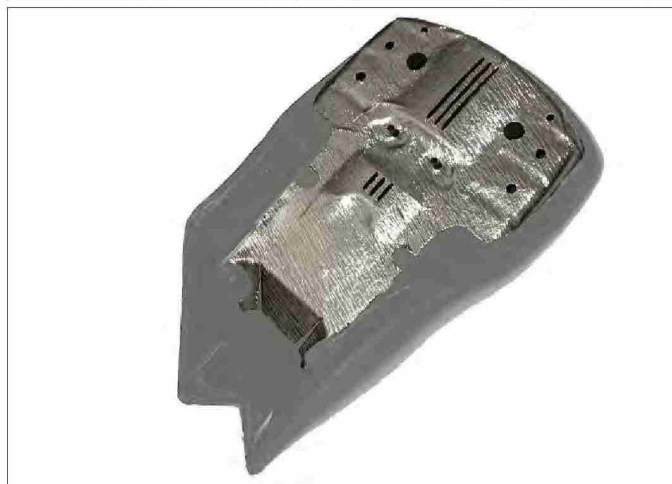
4. Thoroughly clean the highlighted surface of the rear cab with warm soapy water and a sponge. Dry the rear cab with a lint free cloth.

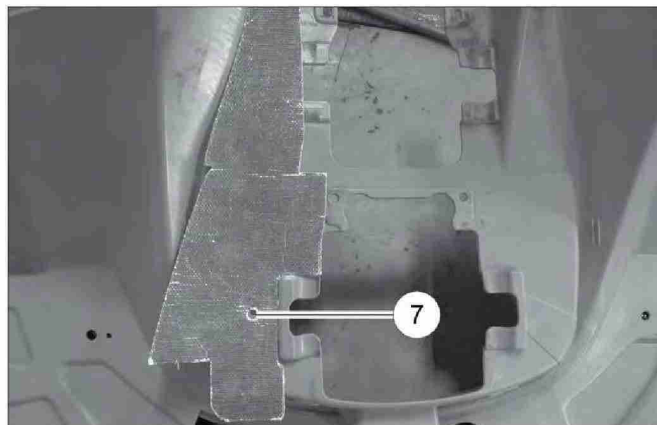
5. Install the rear cab heat shield foil (5814631) ⑥ on to the rear cab.

Align the hole ⑦ in the rear cab foil ⑥ with the fastener hole in the rear cab.

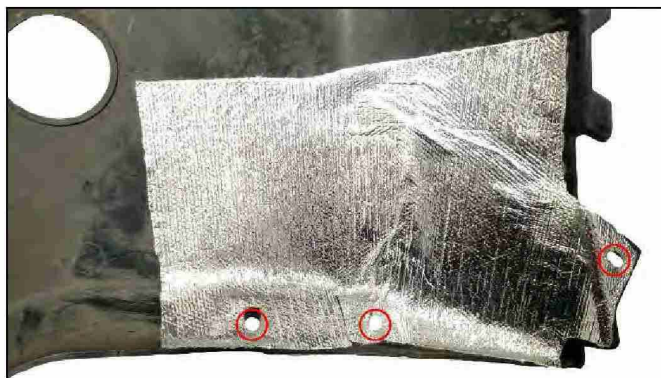
7. Install the side panel heat shield foil (5814632) on to the upper side shield.

Orient the foil on the side panel as shown. Start with adhering the foil directly on the holes, then move inward. The foil does not need to lay smooth, wrinkles are acceptable.

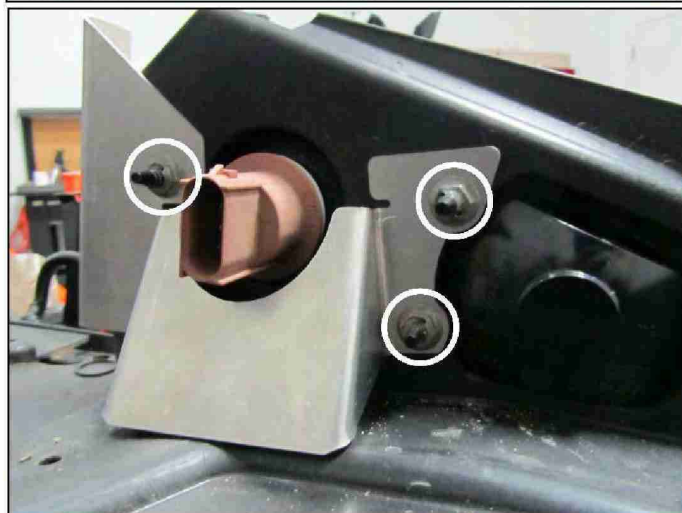
11. Align the NEW rear cab heat shield (5263209) with mounting holes, and install the nylon plastic dart clips.

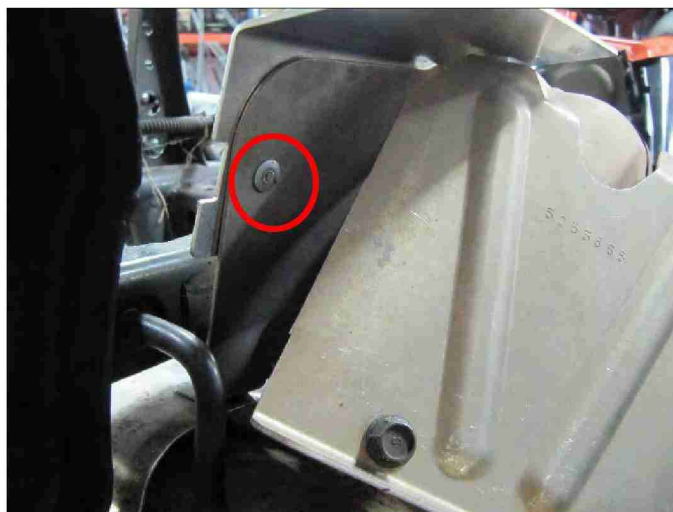
The new rack support shield bolts go through the second and third holes down as shown in the picture. Do not use the top rack support hole as a mounting location.

17. Using a rivet gun and installing from the wheel side of the shield, rivet the rack support shield through the hole drilled in the previous step using the rivet supplied in the kit. Release the locking pliers.

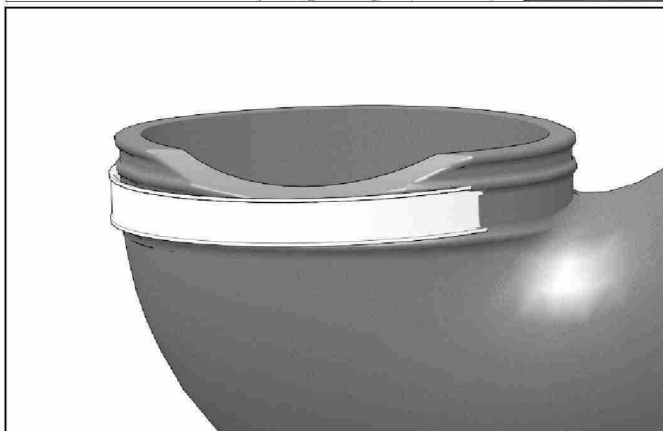
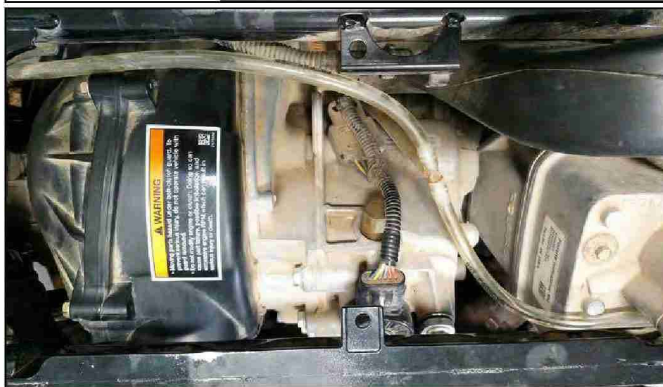
3. Pull the upper rear of the footwell towards the right side of the vehicle, then slide the NEW exhaust manifold side panel (2636626) along the head pipe and release the footwell.

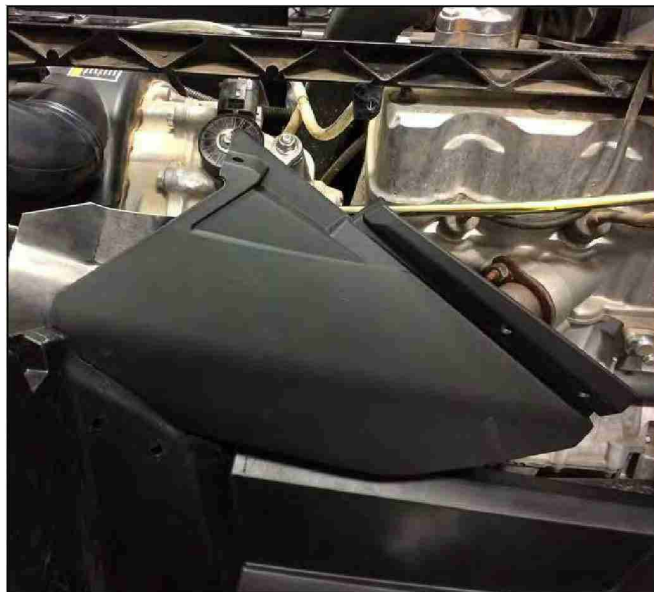
A secondary dealer representative must verify the new exhaust manifold side panel (2636626) has been installed and the original exhaust manifold side panel has been discarded.

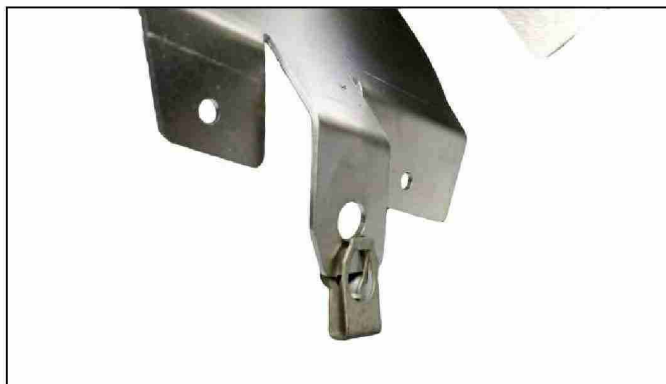
4. Install U-clip (7547366) to single hole tab on the footwell heat shield as shown.

Flat side of clip should be facing towards footwell.

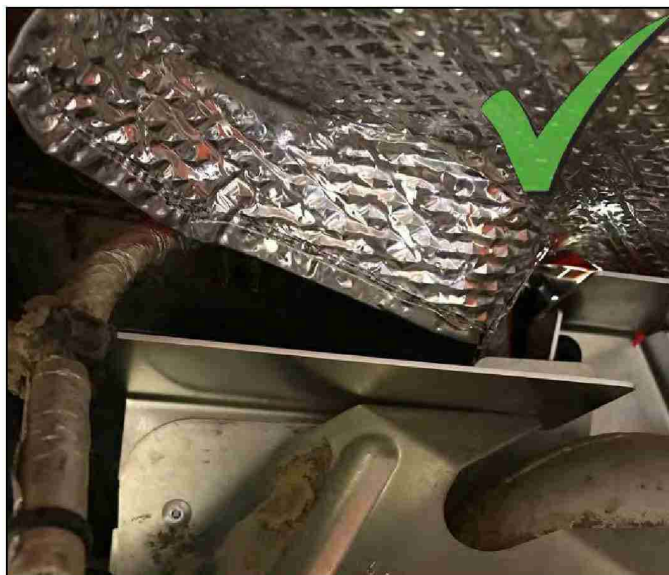
Acceptable – Rear Cab Heat Shield wraps around the corner of the storage box and tail light harness

A secondary dealer representative must verify the Rear Cab Heat Shield is bent down and wraps around the corner of the Storage Box and Tail Light Harness. If it interferes when installing the cab, ensure it is bent back down to match the good example below.

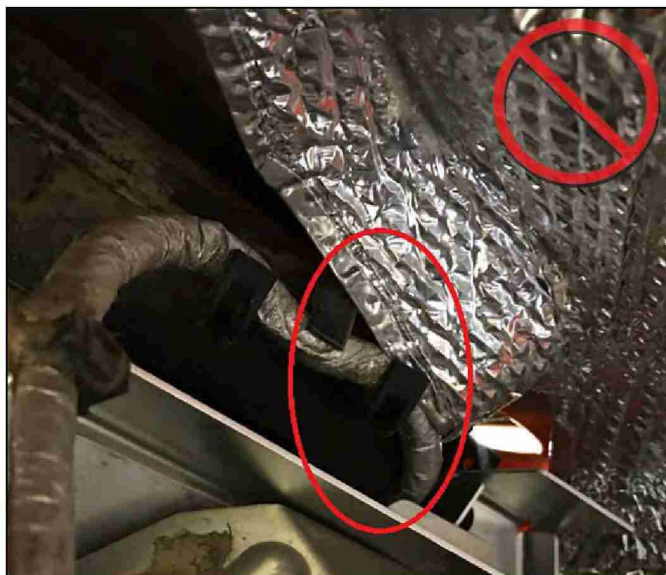
Unacceptable – Rear Cab Heat Shield interferes with the storage box and harness

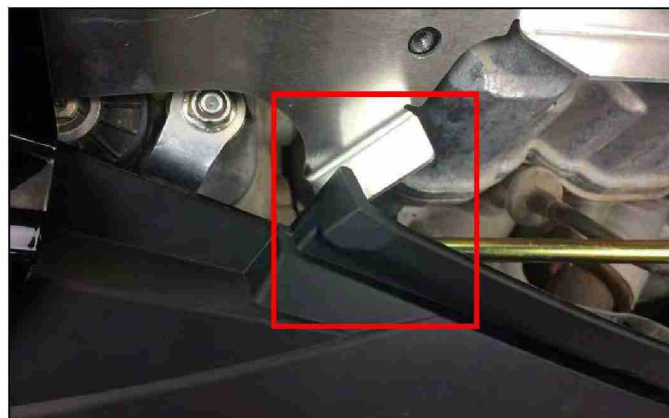
Verify the NEW exhaust manifold side panel tab is on top of the tab on the front cab shield as shown.

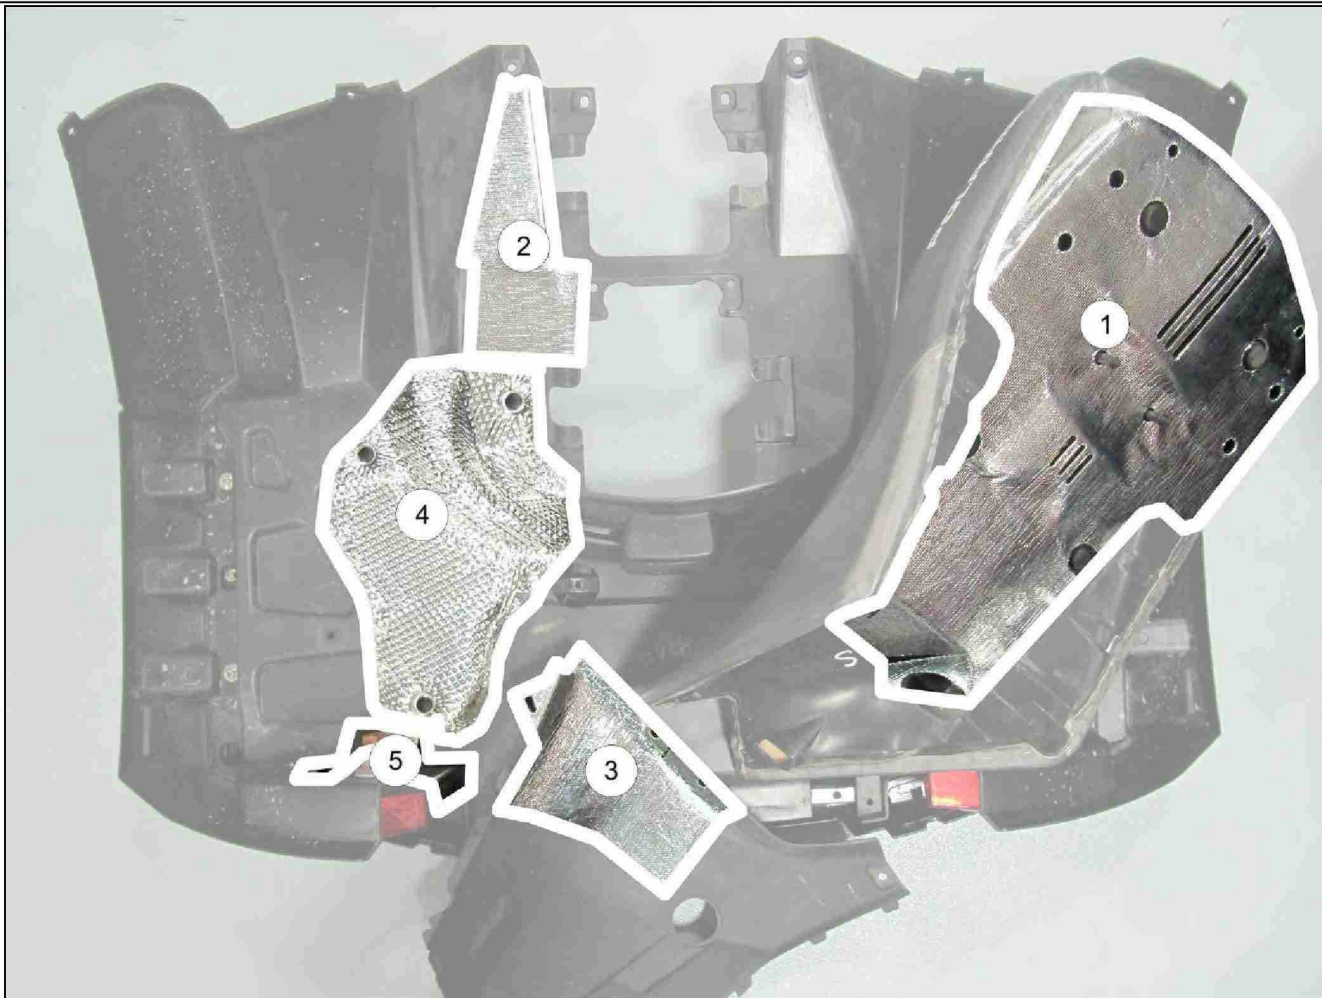
PHOTO 1 - 850/1000 HIGH LIFTER - New Thermal Protection Foils

| ① | Seat Heat Shield Foil | 5814630 |

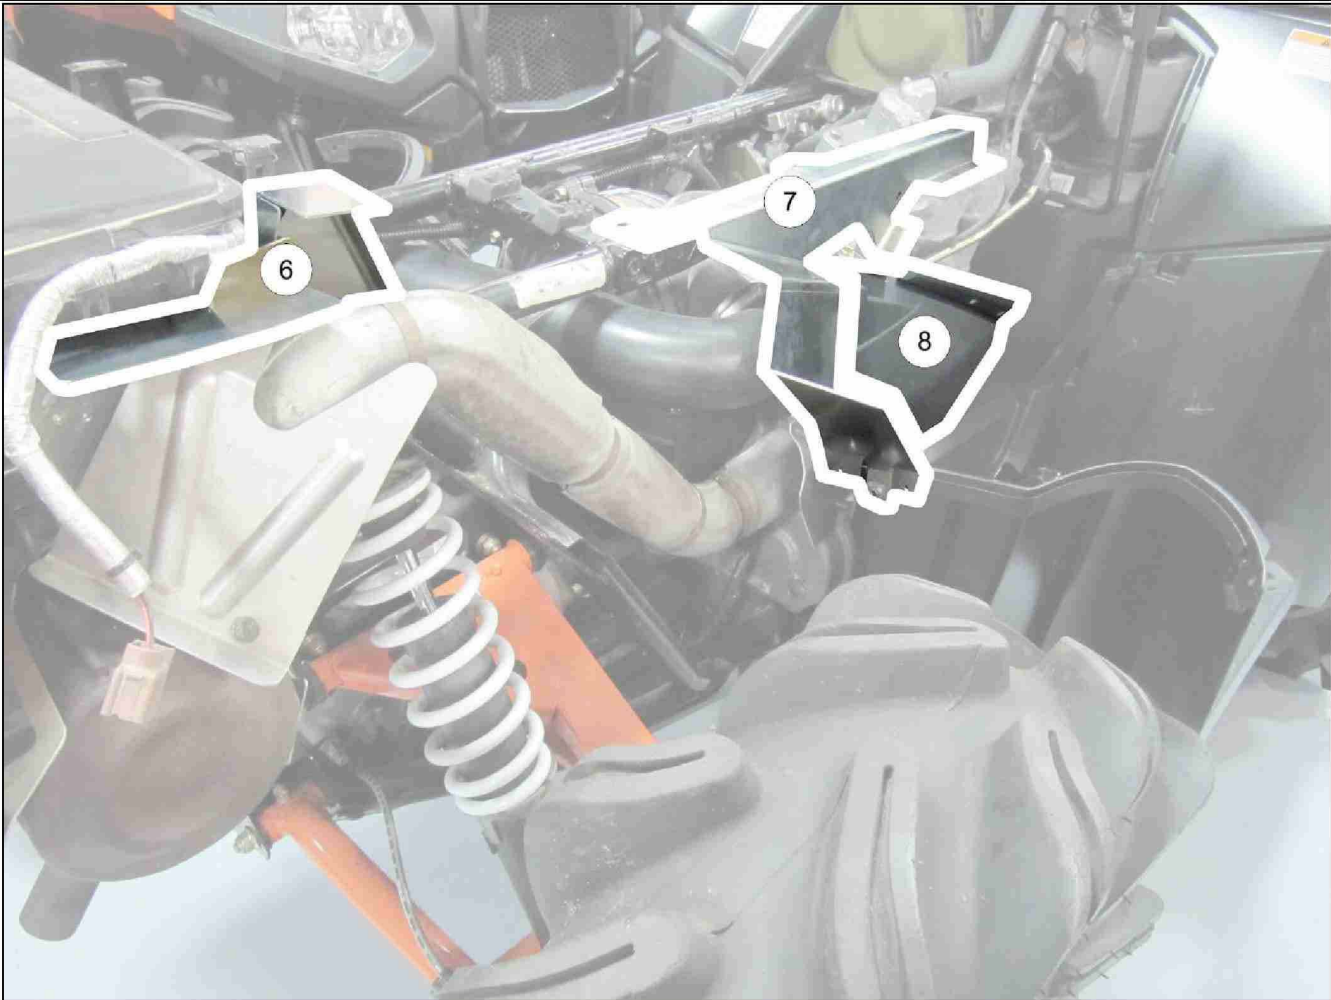
PHOTO 2 - 850/1000 HIGH LIFTER - New Heat Shields

| ⑥ Rack Support Heat Shield | 5264561 |
